Manhole Inspection Summary

Manhole # S59I__020MH

Insp Date: **5/15/08 2:47 PM**

Location Address: **526 oldham**

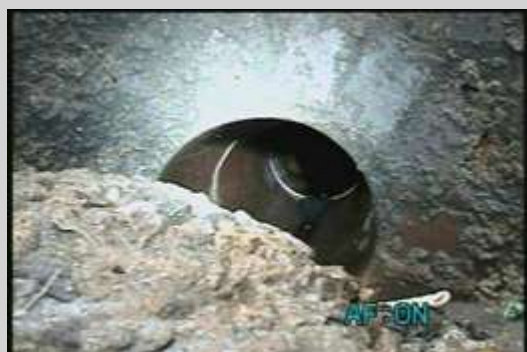
12 O'Clock Outflow

8 in. Circular Gravity Sewer
Pipe Out @ 12 O'Clock

Infiltration: **None** Pipe Seal Cond: **Unknown**
